## UNUSUAL ENGINEERING FEATURES OF THE AL MALAIKAH TEMPLE,

LOS ANGELES

JOHN C. AUSTIN, Architect

By R. McC. BEANFIELD, Assoc. M. Am. Soc. C. E., Consulting Engineer

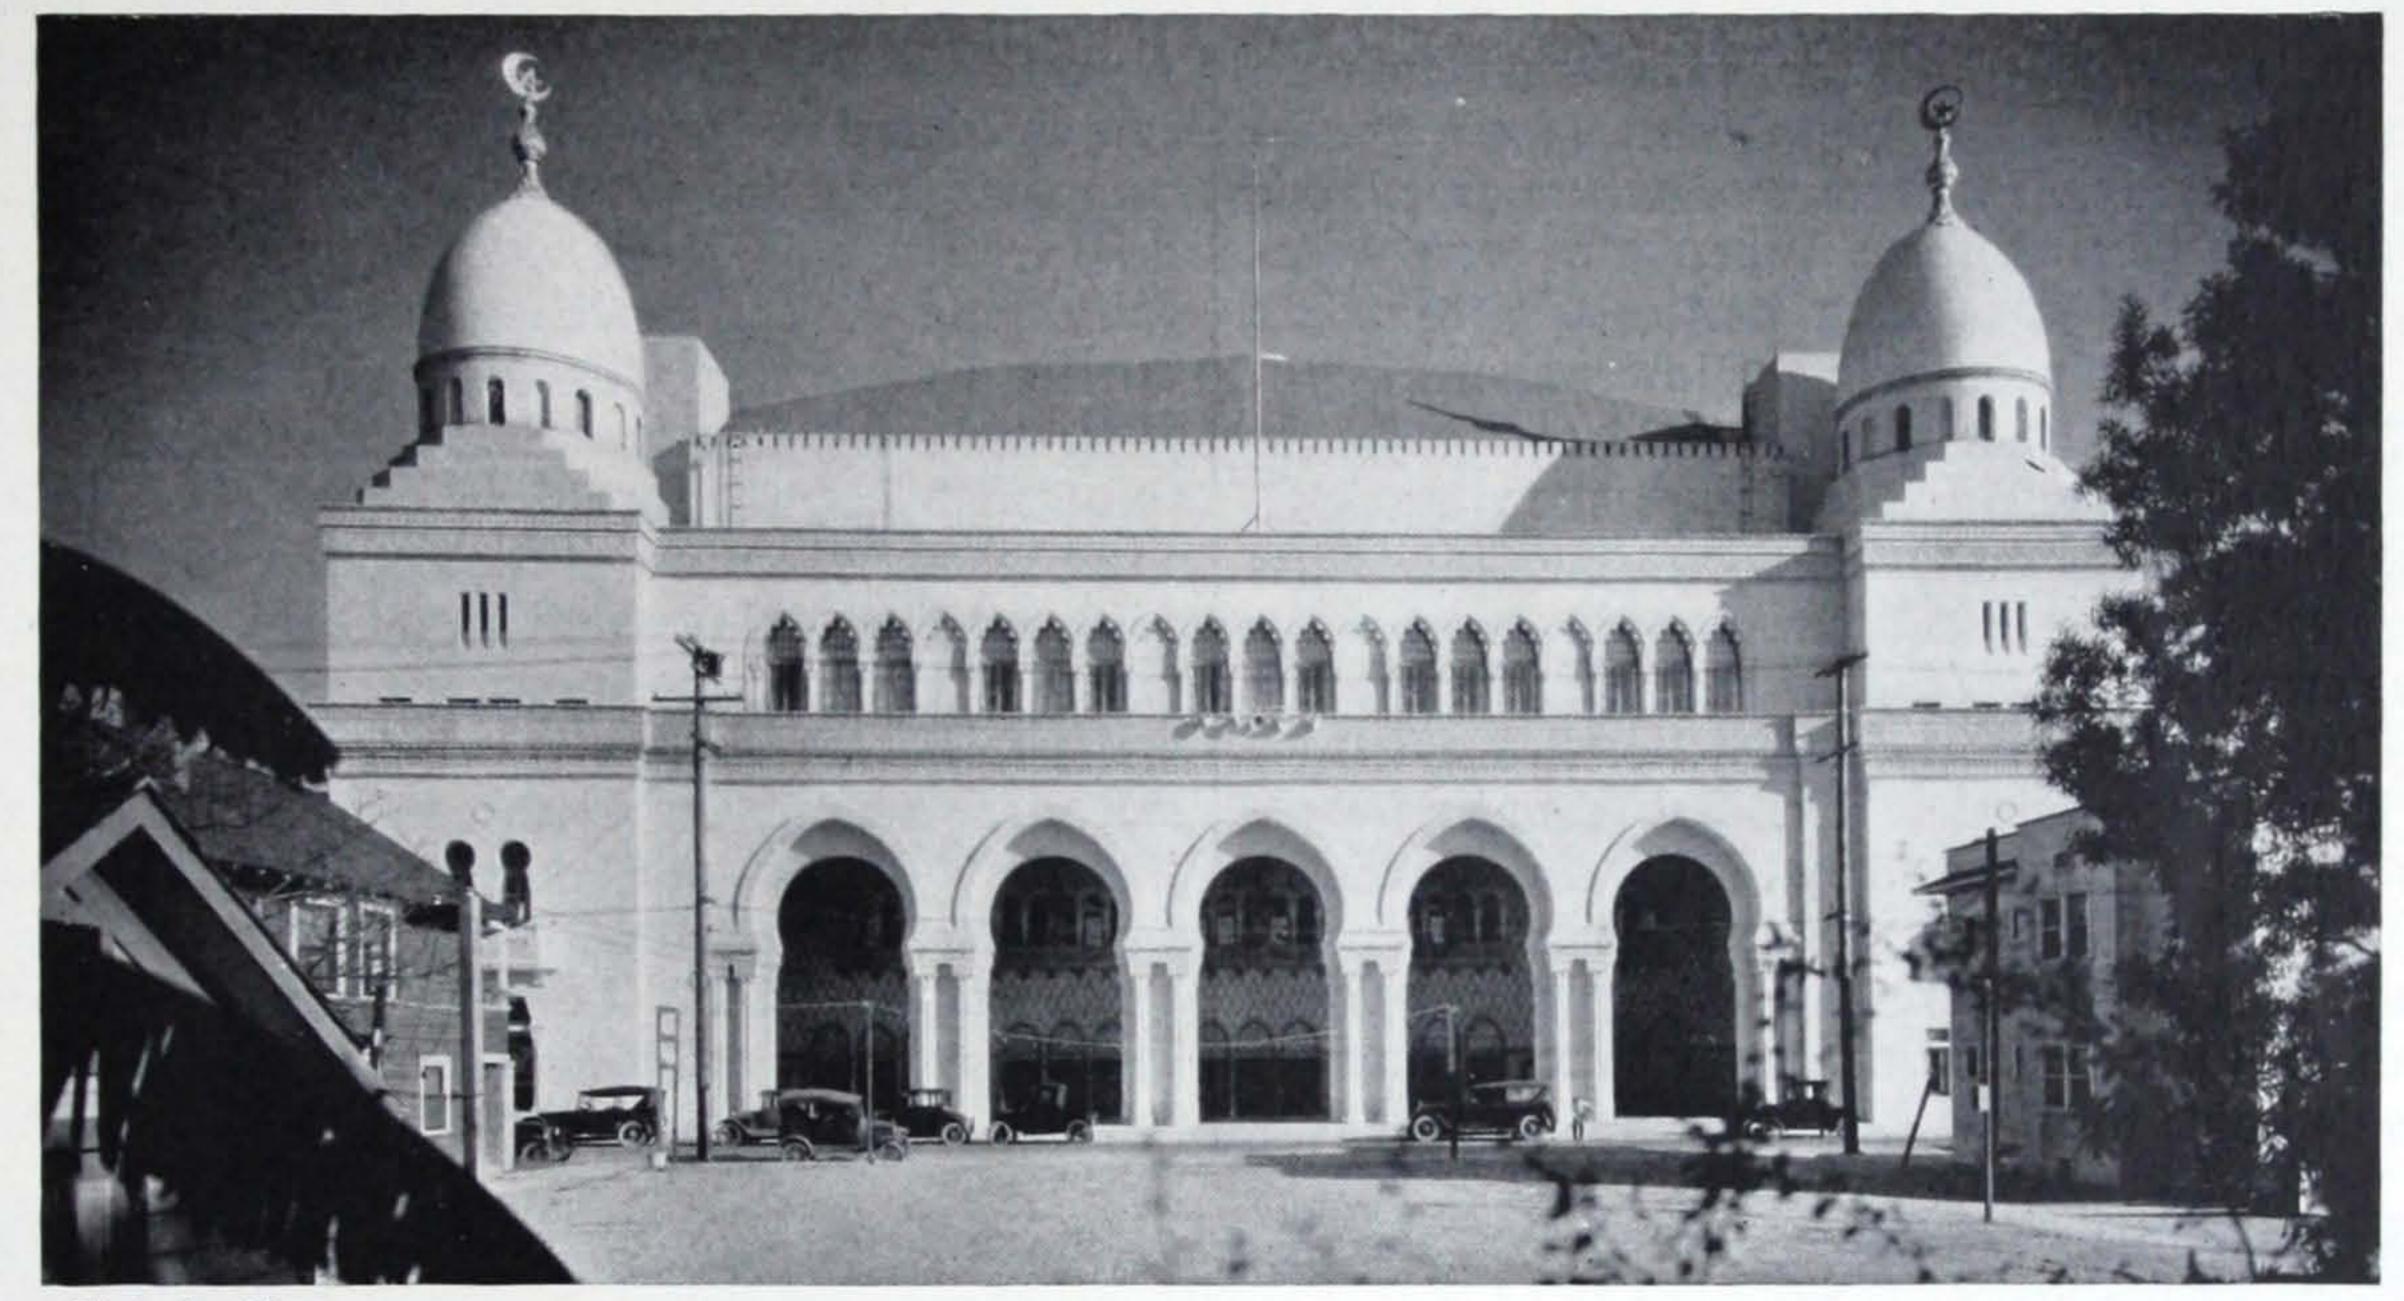
Photo by Mott AL MALAIKAH TEMPLE, LOS ANGELES, CALIF.—JOHN C. AUSTIN, ARCHITECT

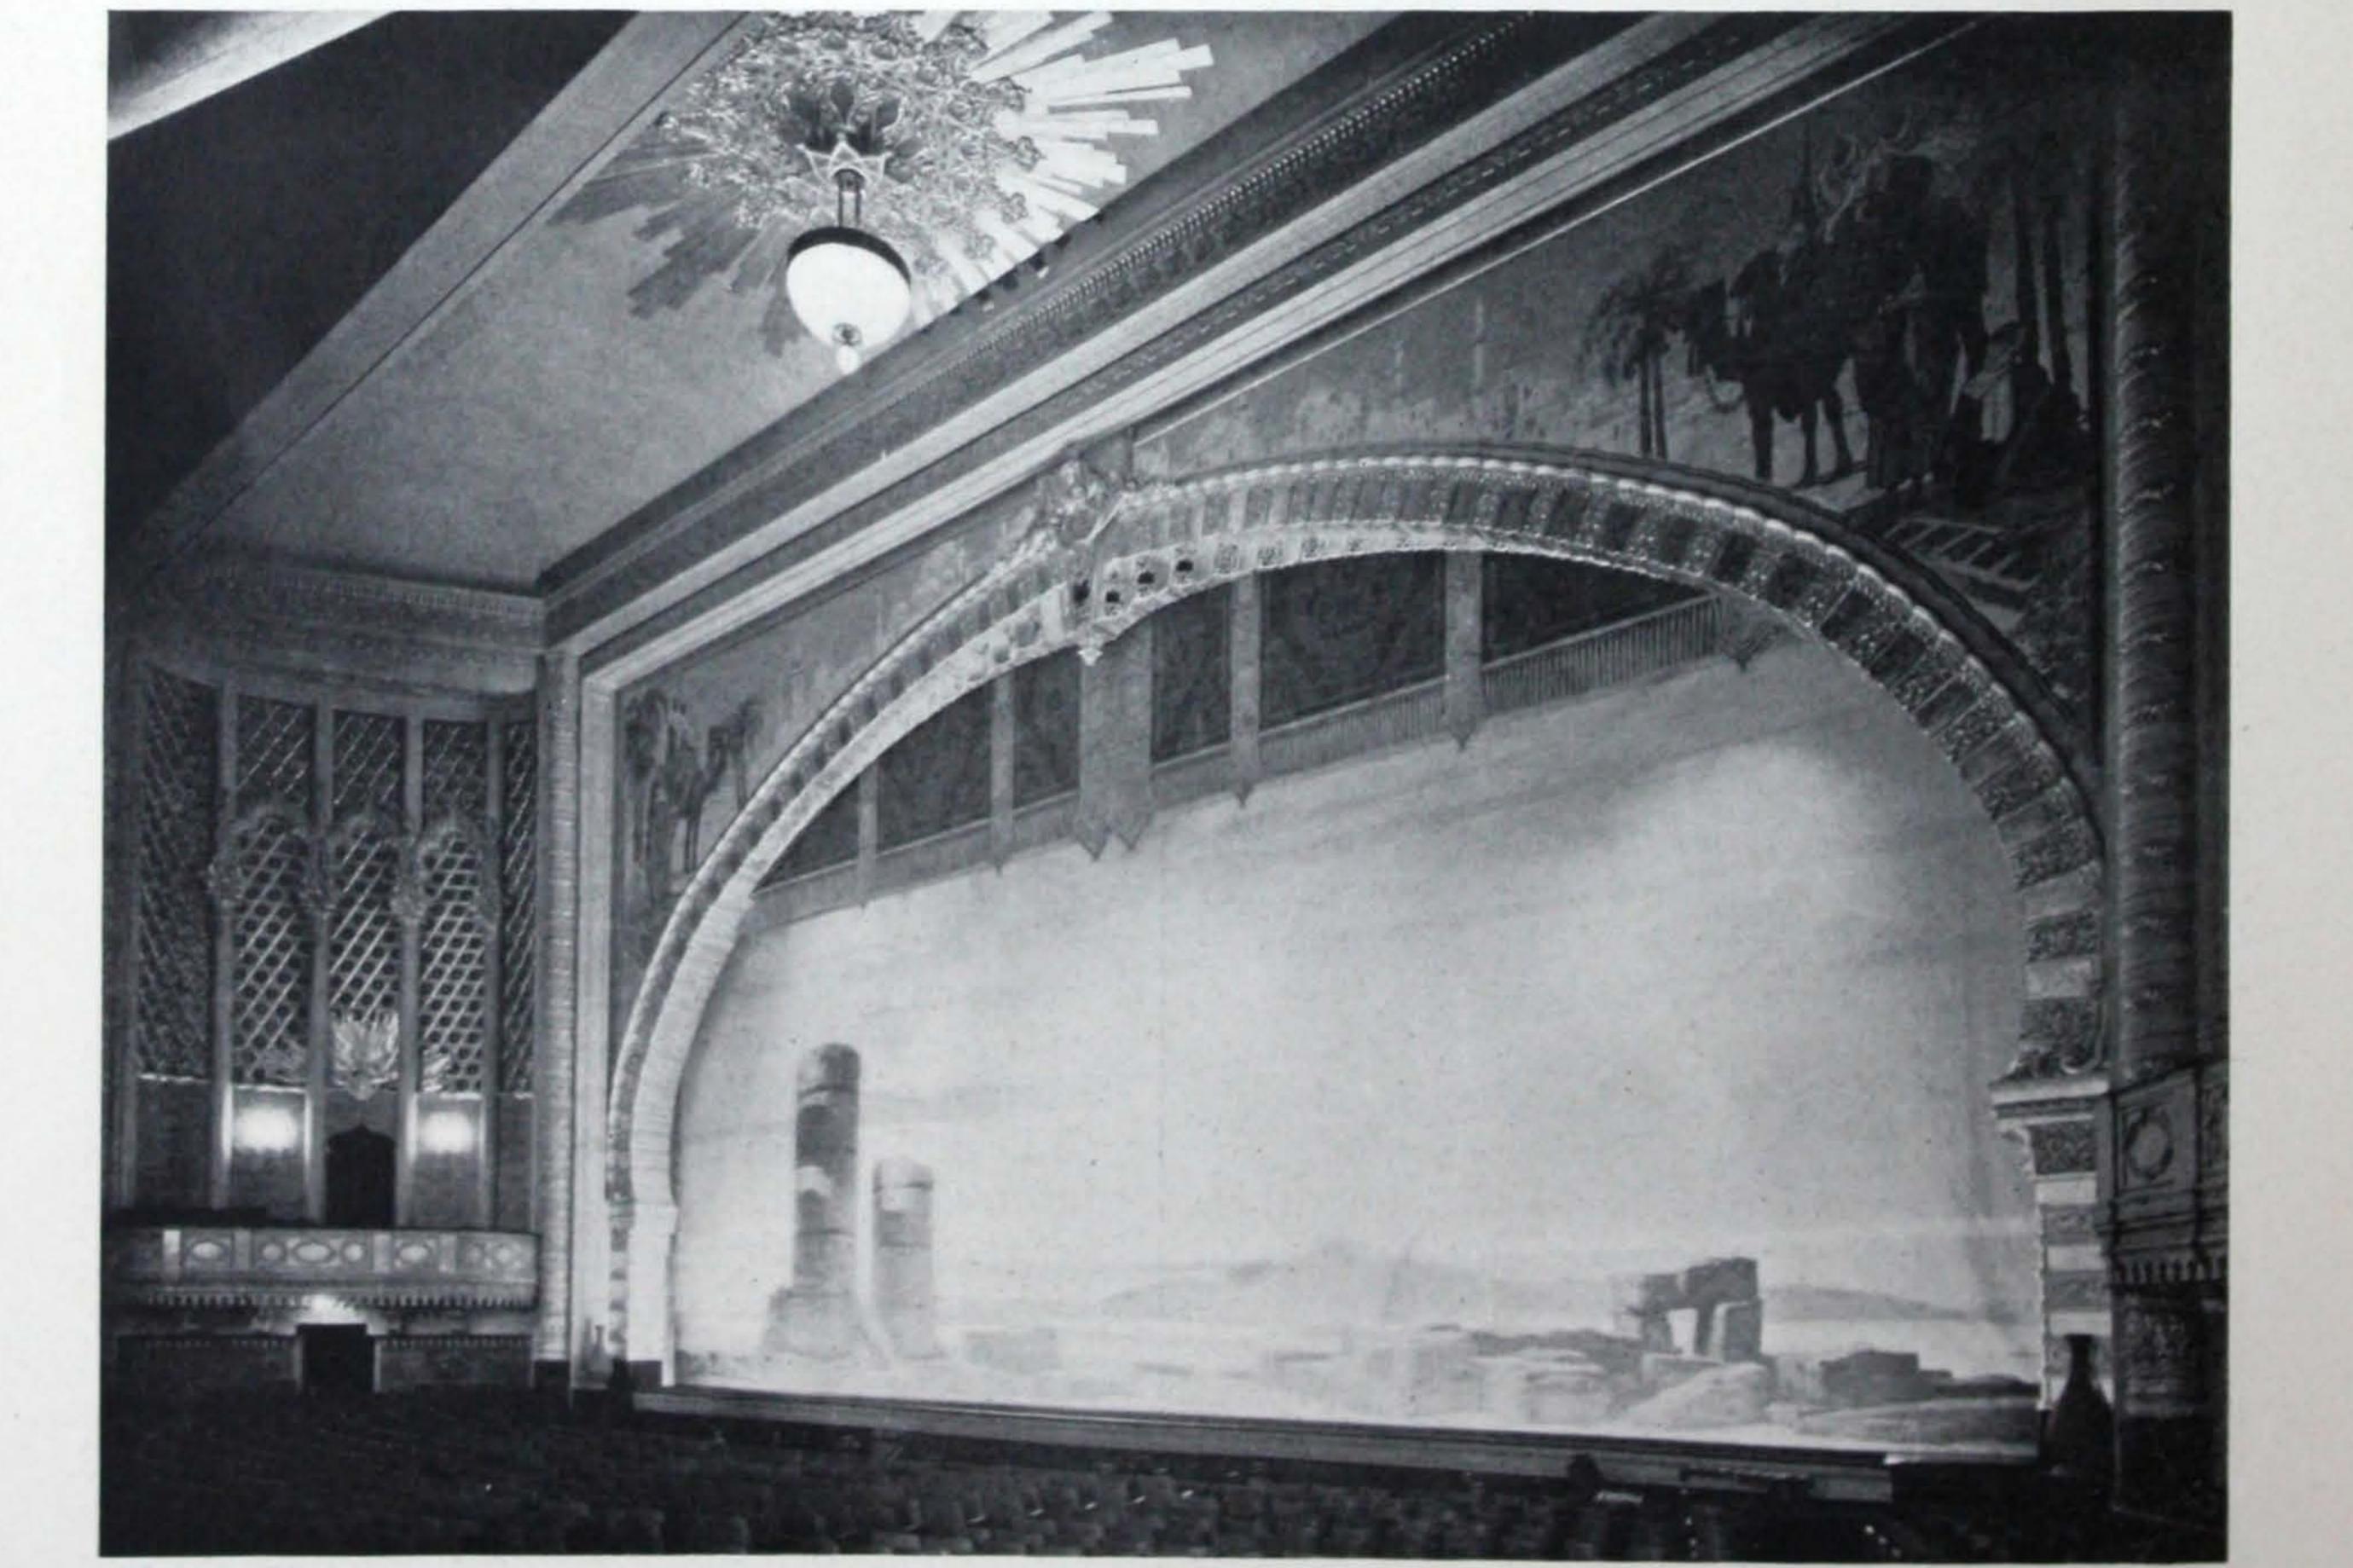
## THE PROSCENIUM OPENING HAS A CLEAR SPAN OF 100 FT. AND A HEIGHT OF 37 FT. AT THE CROWN. AMPLIFYING SPEAKERS ARE CONCEALED IN THE JEWELED CROWN OF THE ARCH

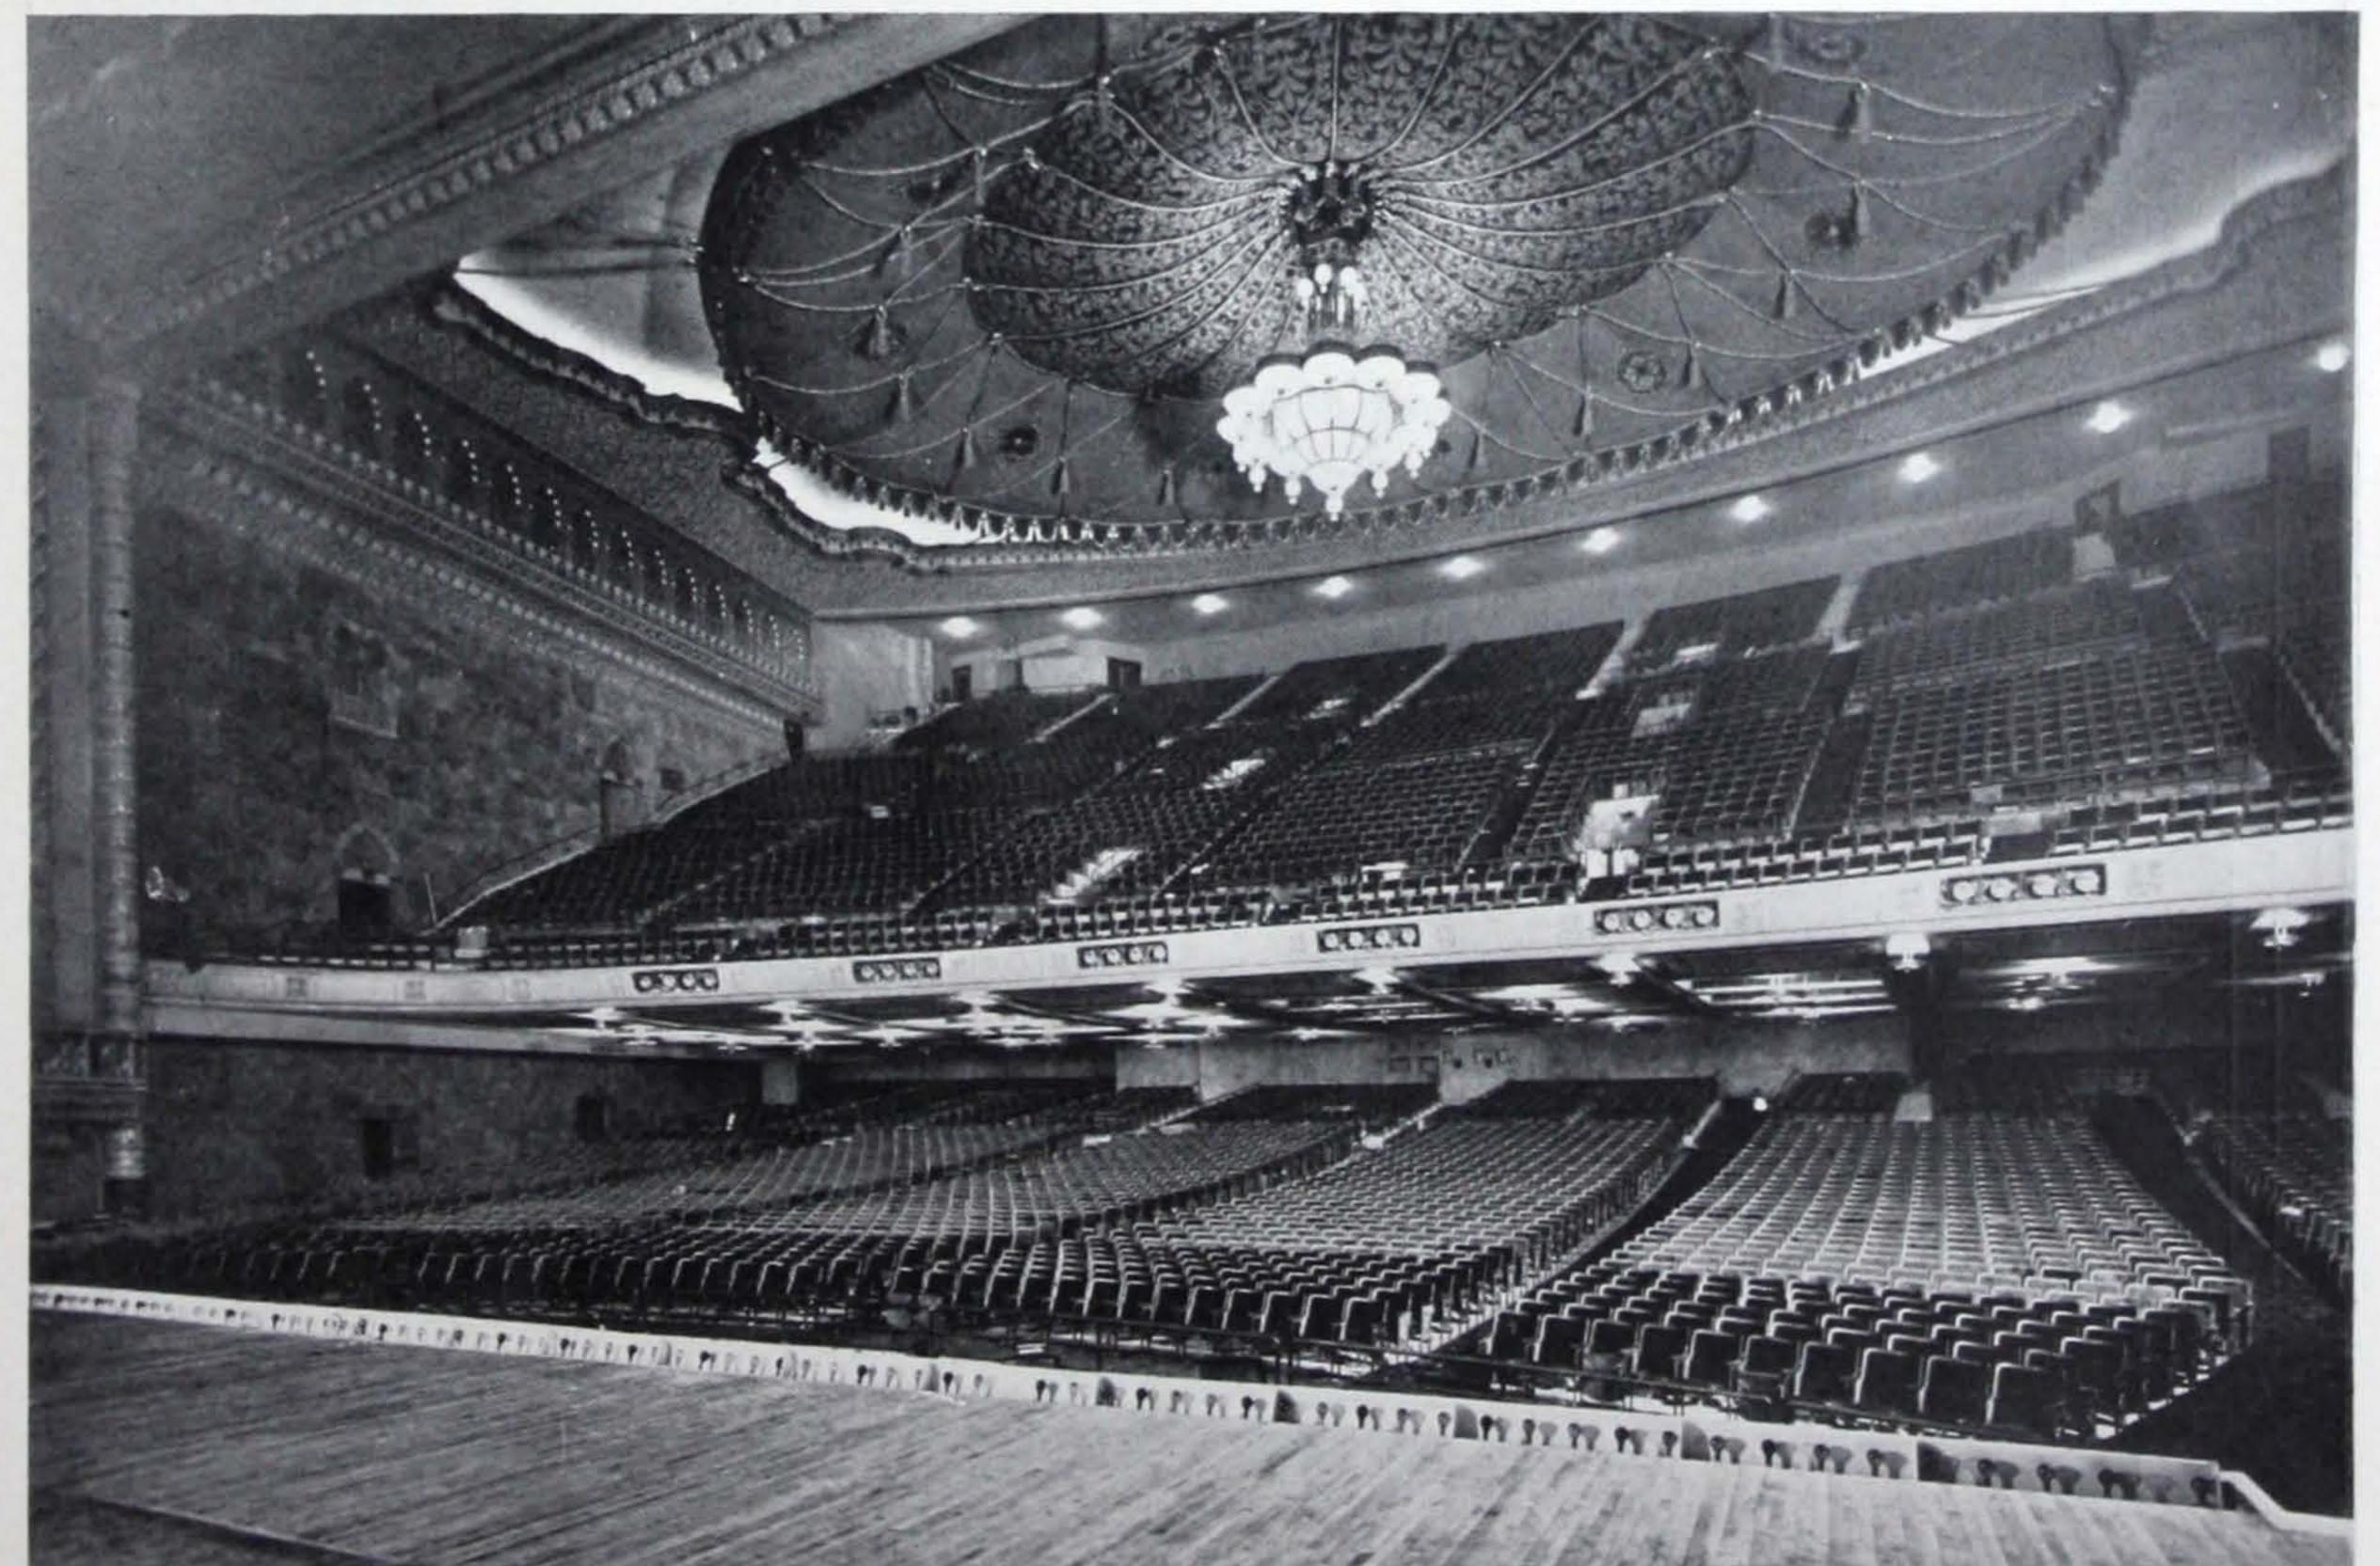
## THE 22 FT. HIGH CHANDELIER, WEIGHING APPROXIMATELY FIVE TONS, IS CONSTRUCTED WITH A STRUCTURAL STEEL FRAME AND HUNG FROM PIN JOINTS. IT CONTAINS 500 ELECTRIC BULBS, ARRANGED FOR 64 COLOR COMBINATIONS

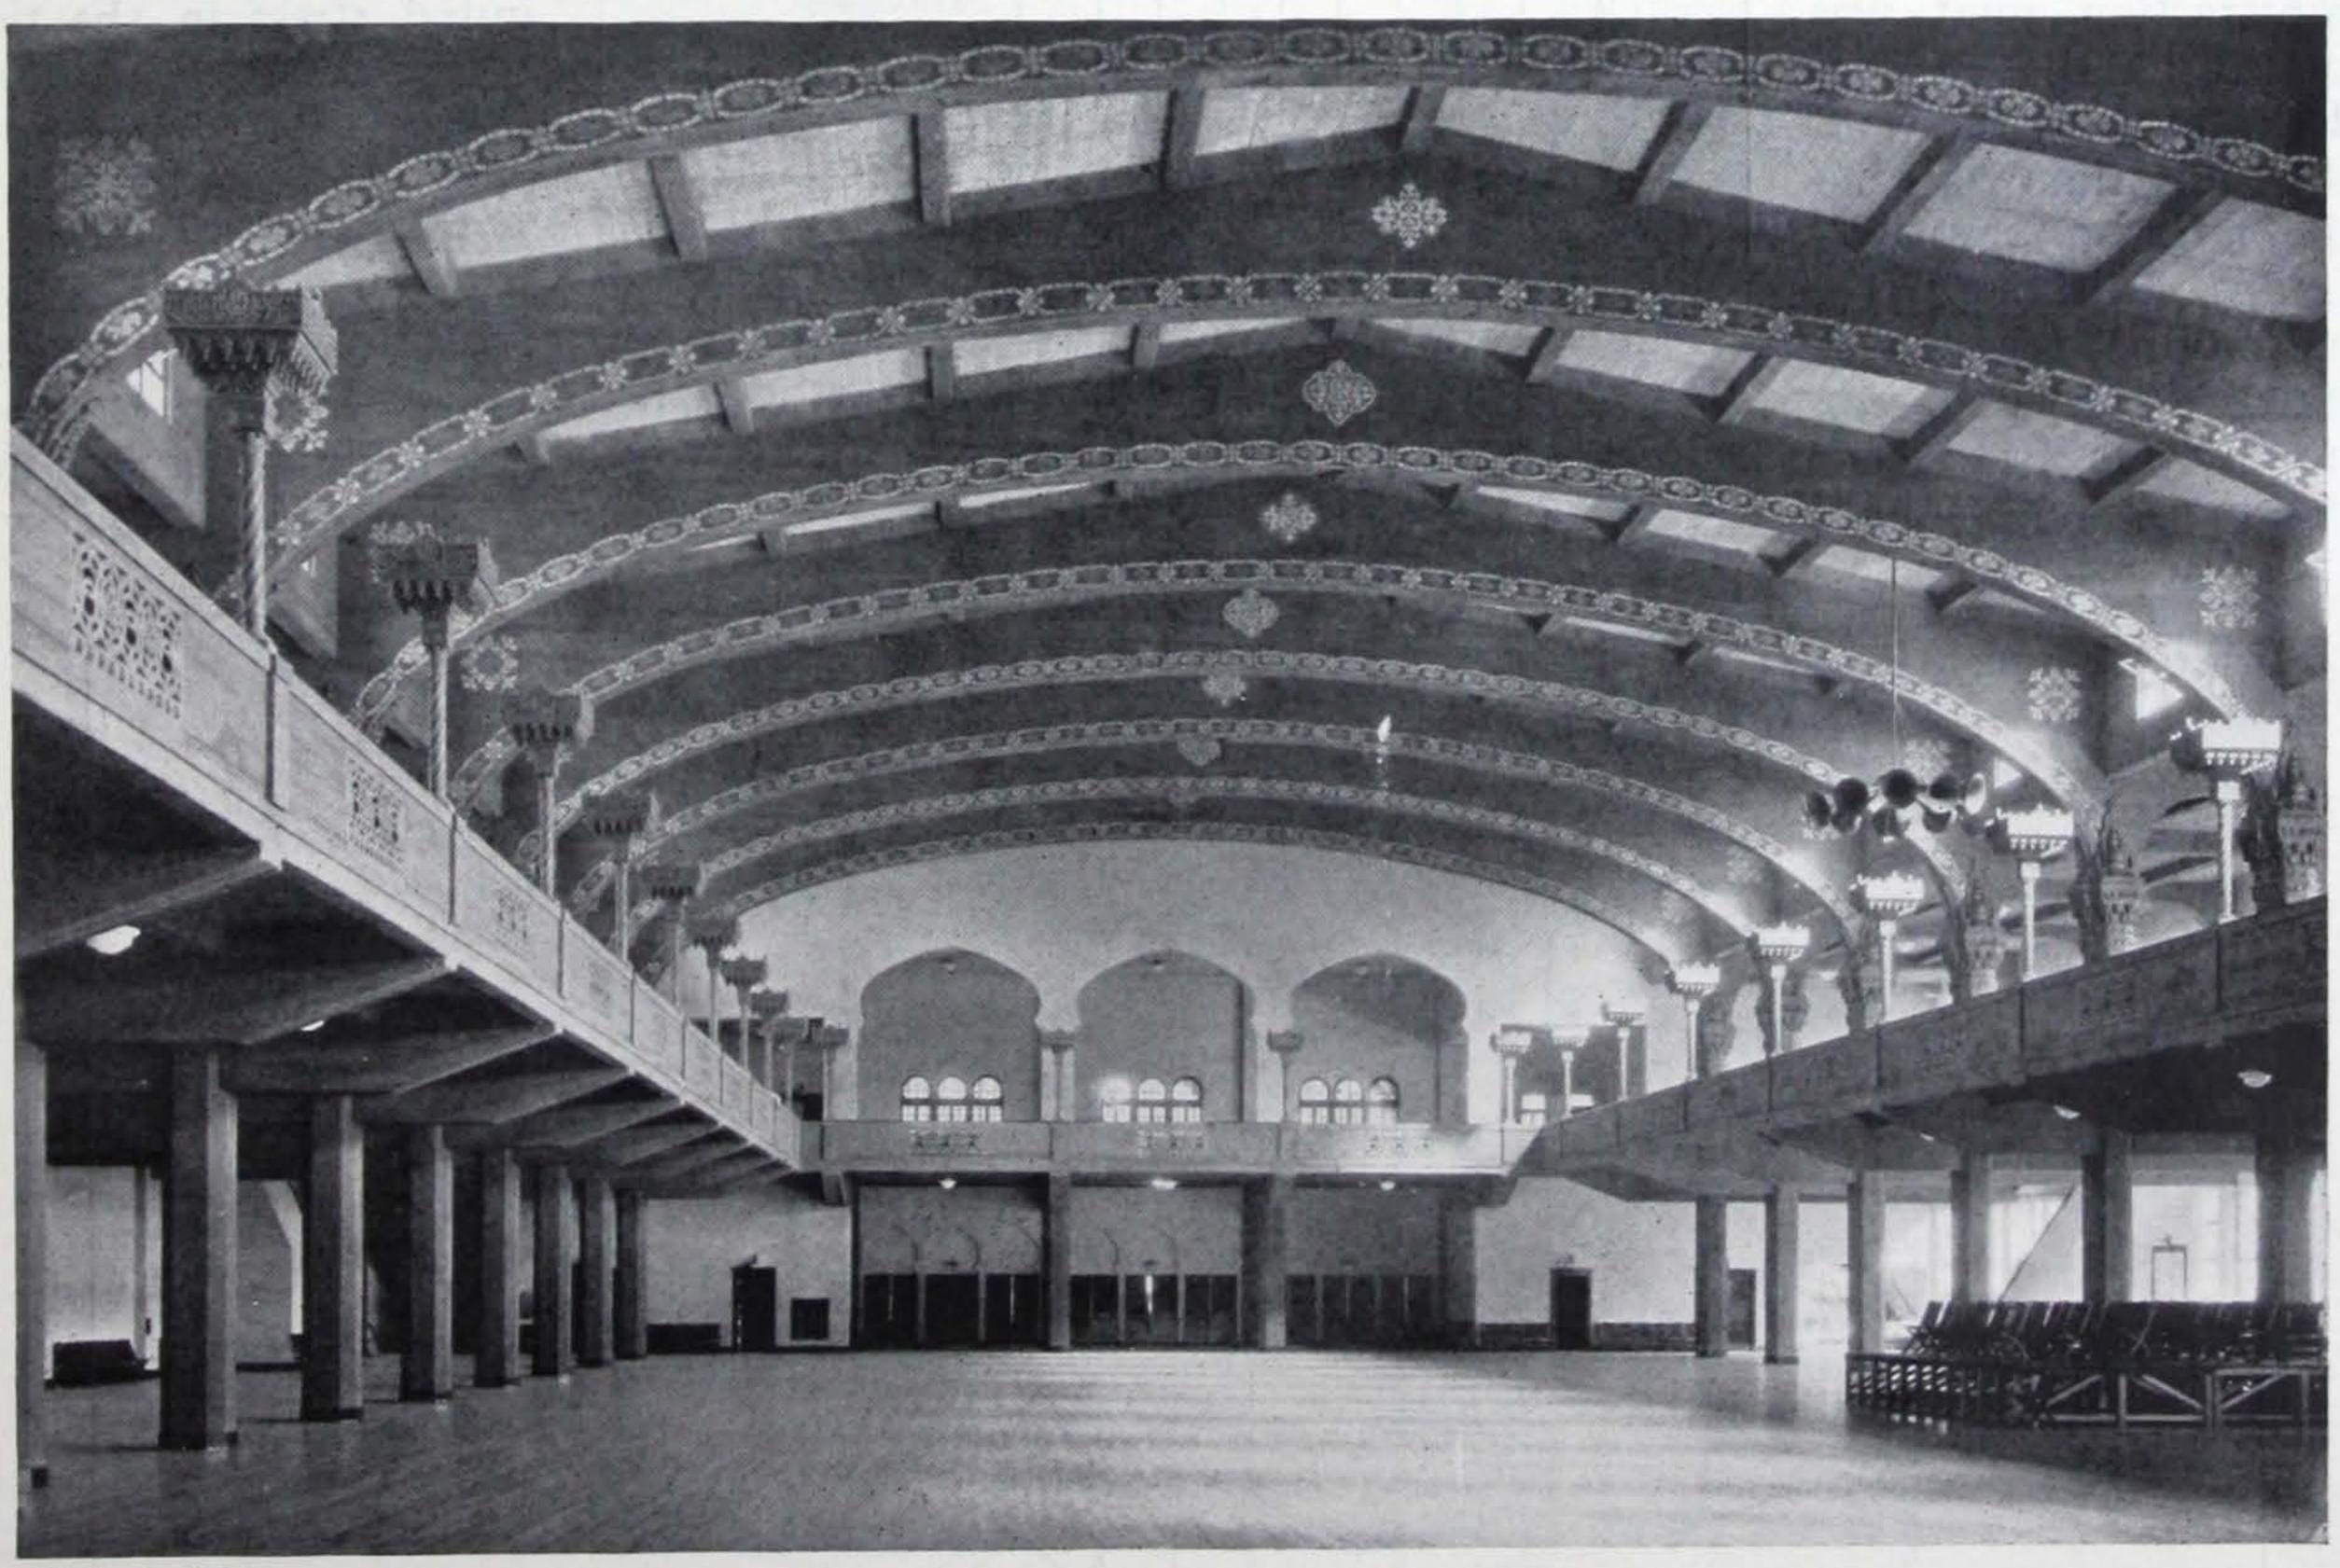
THE ROOF OVER THE BANQUET HALL IS SUPPORTED ON REINFORCED CONCRETE ARCHES OF 90 FT. CLEAR SPAN. BENDING STRESSES IN COLUMNS ARE REDUCED BY THE CANTILEVERED BALCONY. DECORATIONS ARE PAINTED ON CONCRETE

The continuous reinforced concrete girders, supporting the banquet hall roof, were designed as a part of a fixed frame. The soffits of the roof girders were curved to represent Saracenic arches, which added to the depth of the girders over the interior columns where large negative moments existed. The use of balcony cantilever girders tended to reduce the moments in the columns. The rear, or wall, columns were required to resist an uplift. The anchor arms of the continuous girders were projected through and above the roof, being hidden from the interior. John C. Austin, F.A.I.A., was the architect. The writer, as chief engineer for the architect, was responsible for the structural design and the design of the heating and ventilating systems.

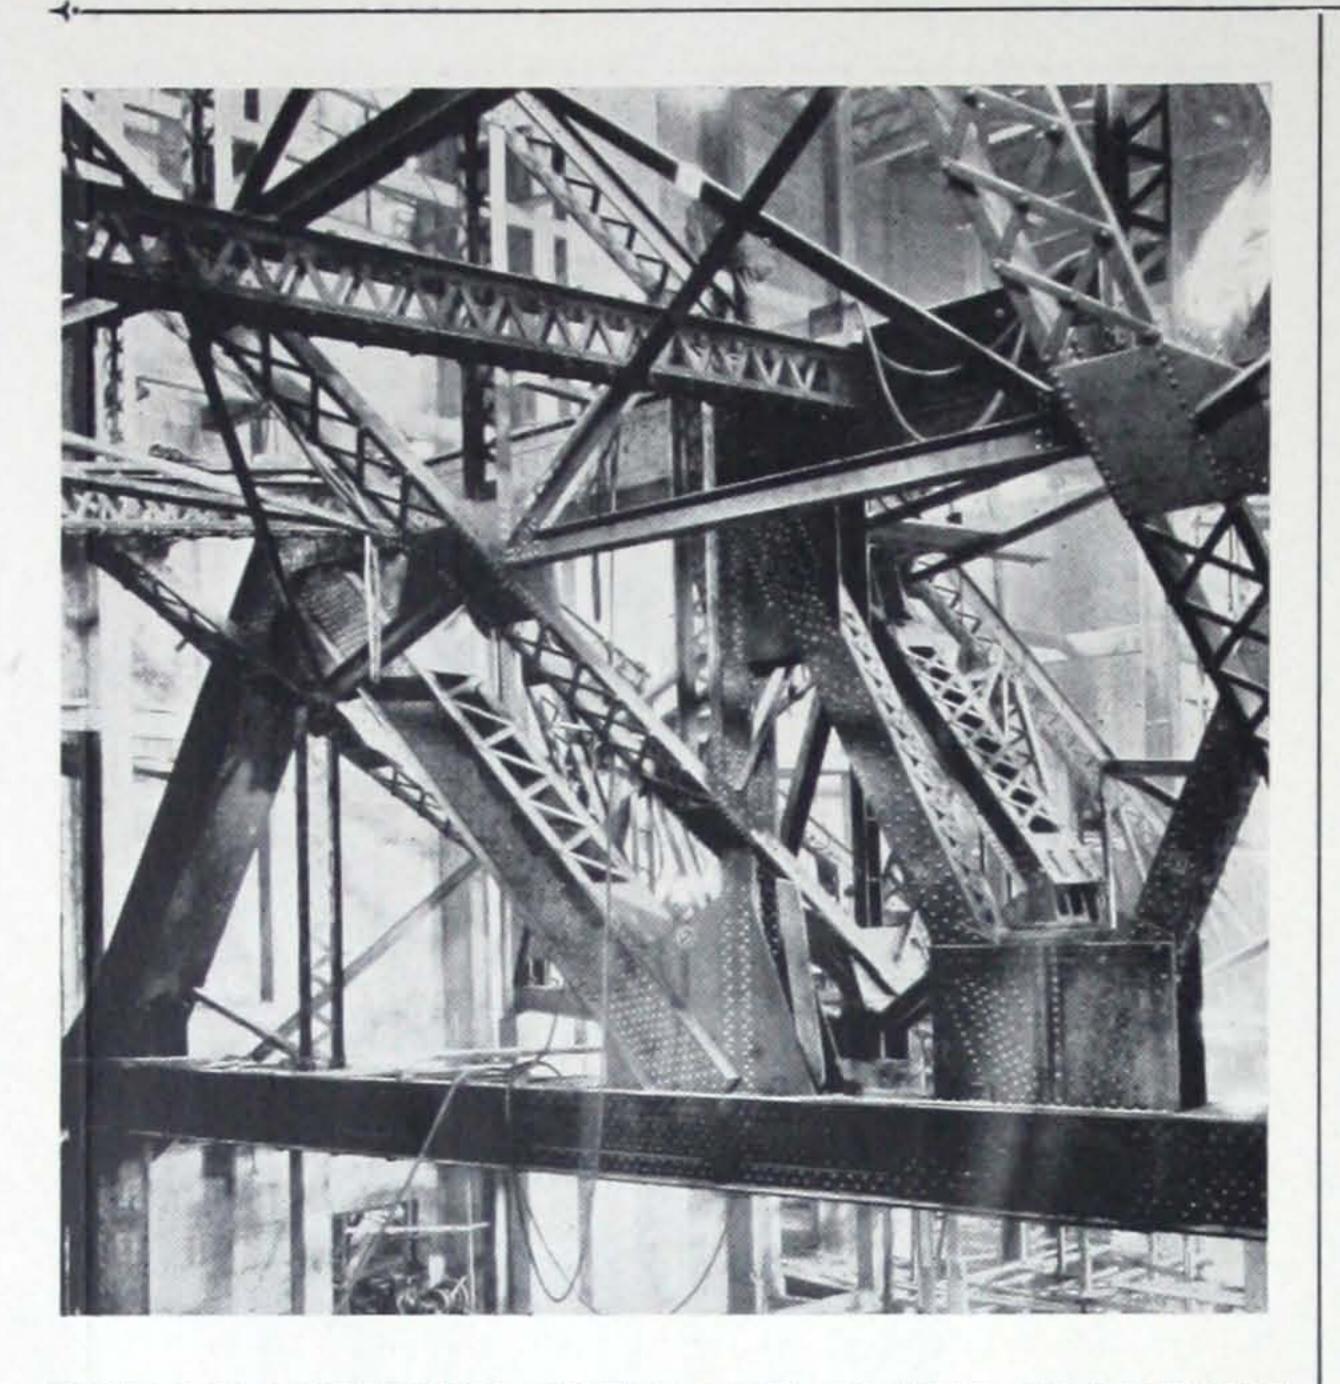
MAIN BALCONY TRUSS SHOWING PIN COLUMN CONNECTION AND PIN CONNECTION OF JACK TRUSS TO STEEL CASTING ON MAIN TRUSS. ABOUT 30% OF HOLES IN CONNECTIONS WERE BOLTED TIGHT BEFORE ONE INCH TAPERED RIVETS WERE DRIVEN UNDER 120-LB. PRESSURE

Jack truss T-1 is attached at one end to the main balcony truss by a pin connection in a large steel casting resting on a built-up stool between the web members of truss T-2. The other end is supported on a reinforced concrete wall column. The chords of truss T-1 consist of two 15-in. channels, with 8-in. H web members. The bottom chord in the end panel section of the balcony truss, T-1, was composed of two 8-in. standard eye-bars to avoid clearance difficulties. The pin joint connecting truss T-1 to the main balcony truss, T-2, eliminated any possibility of excessive restraining moments due to the varying deformations of the connected trusses. balcony truss, T-2; the other four are supported and connected at their fulcrum points to the jack trusses, T-1. The center four cantilever trusses are riveted at their fulcrum supports directly to the vertical member of the T-2 main balcony truss, which is common to both trusses.

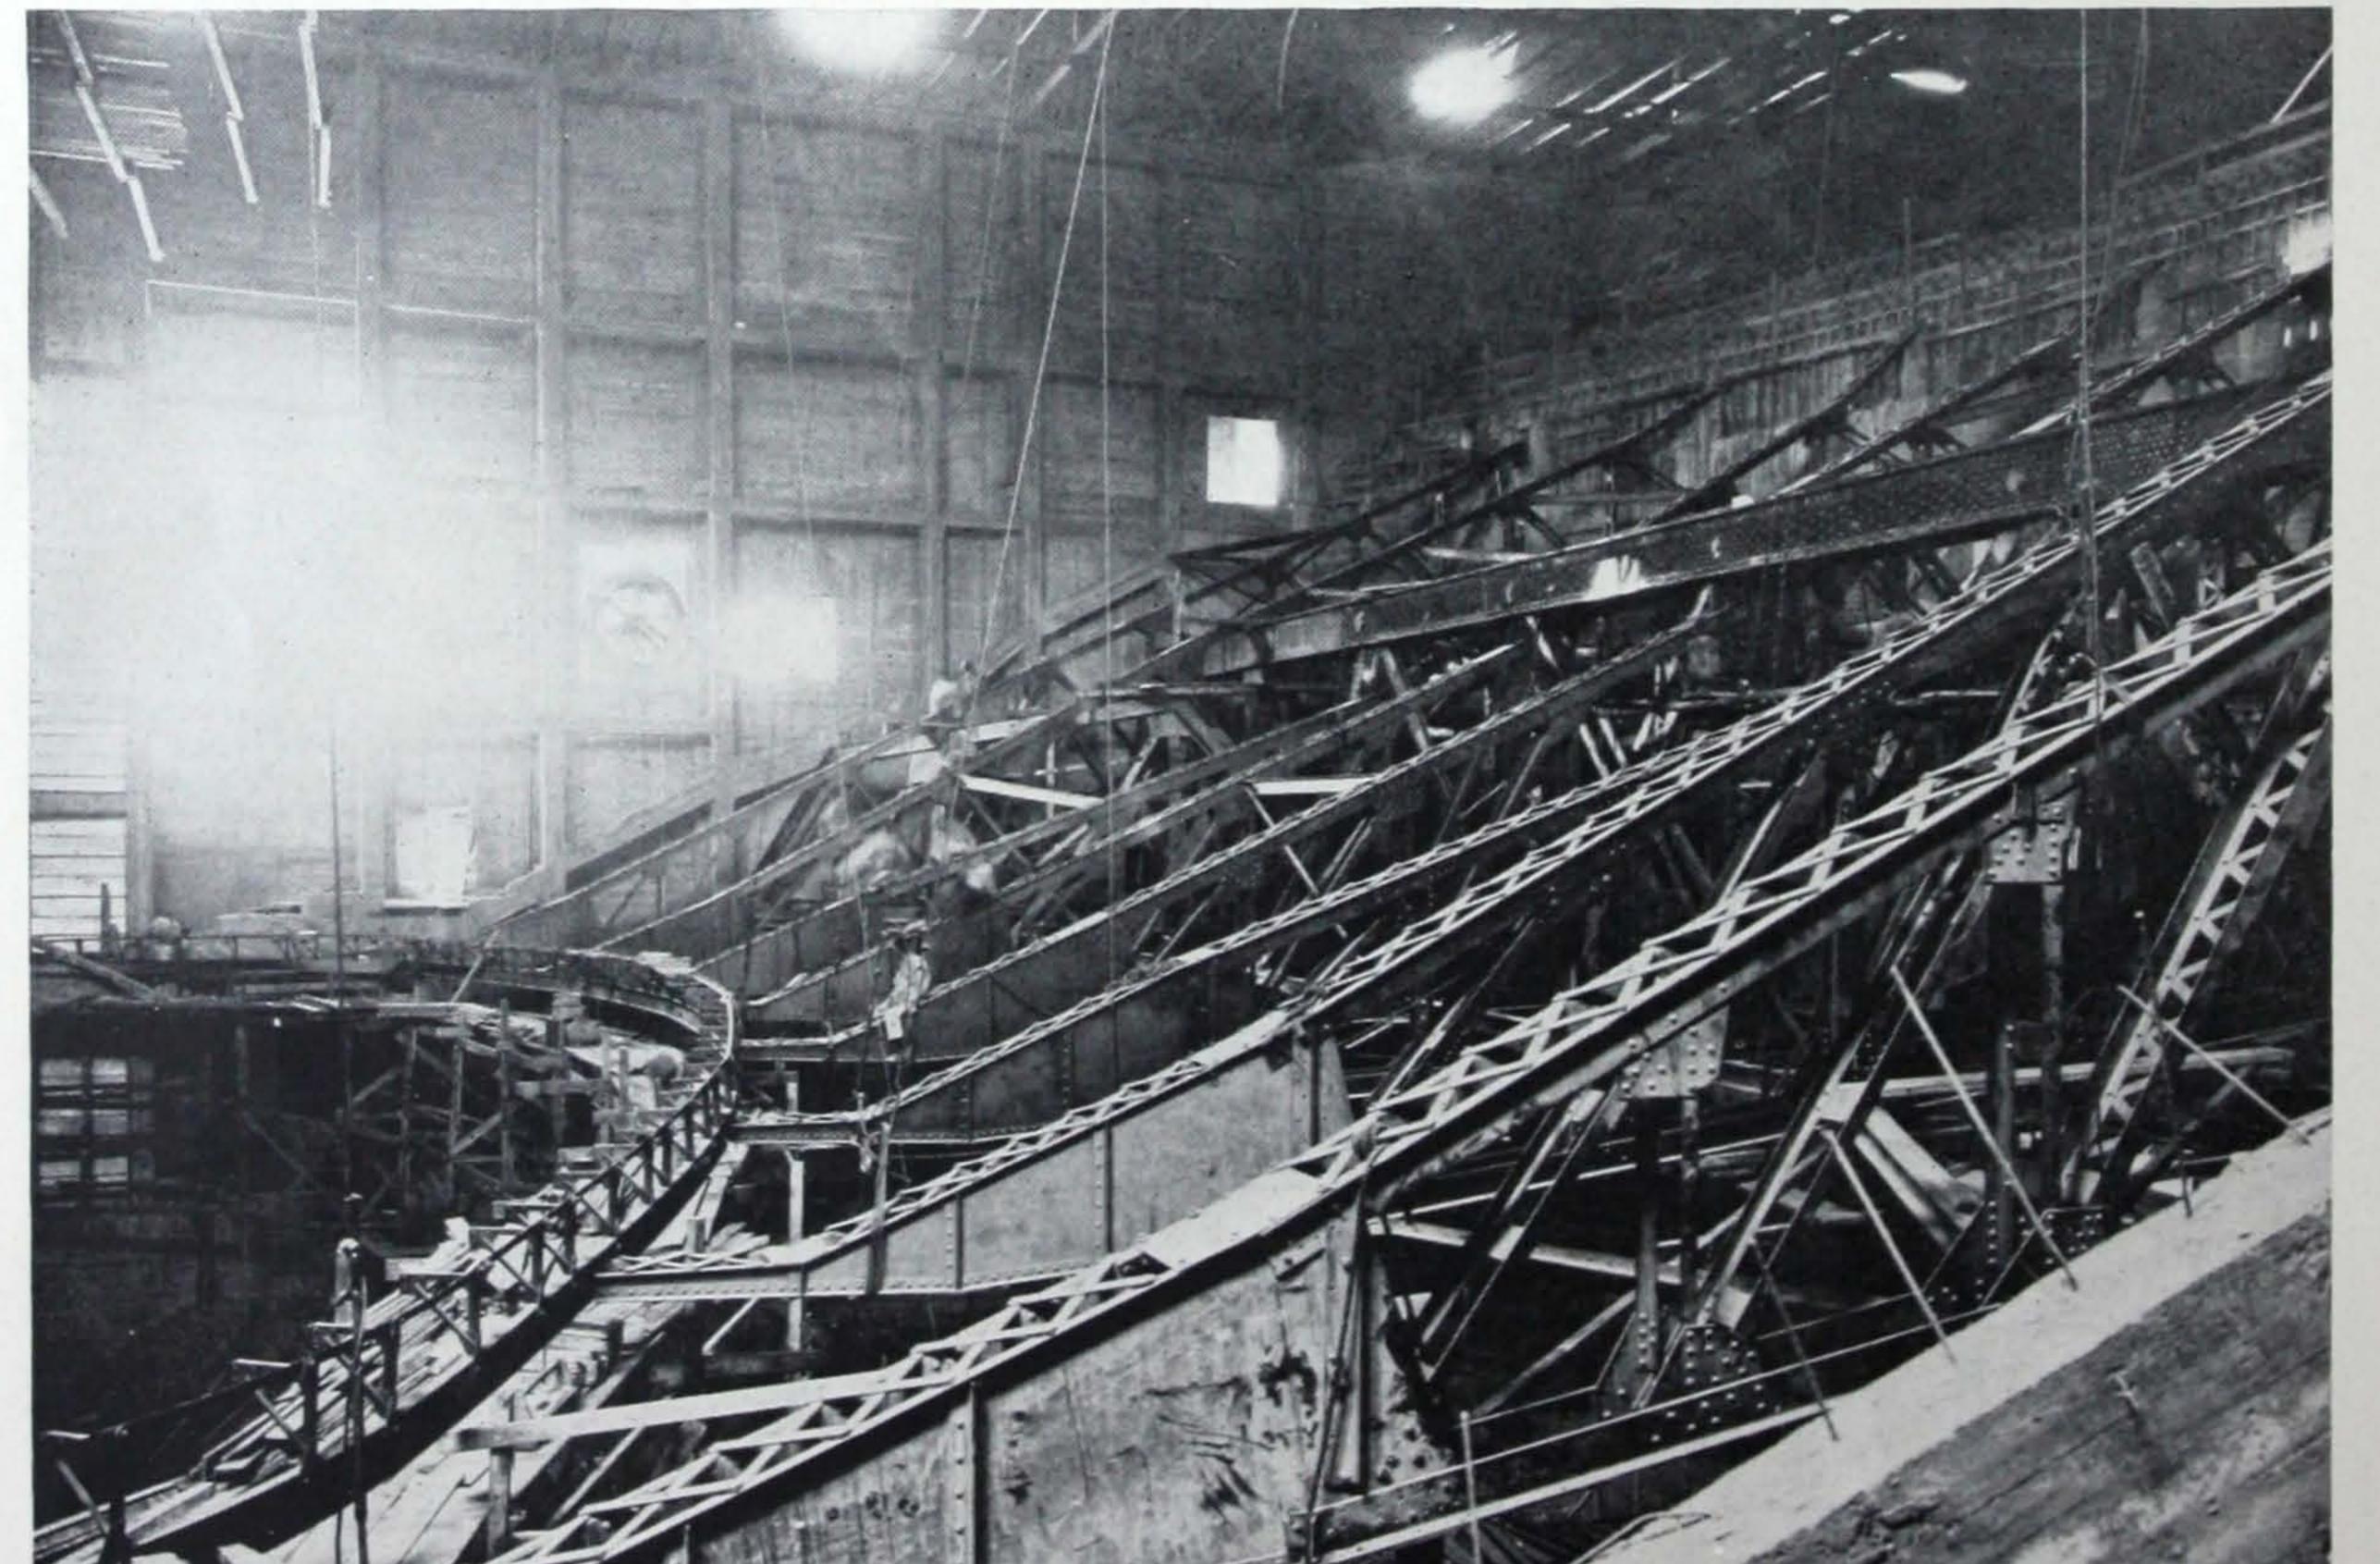
#### Photo by Dwyer OUTER ENDS OF BALCONY CANTILEVER TRUSSES WERE SUPPORTED BY CABLES FROM ROOF TRUSSES BEFORE RIVET-ING. PLATE GIRDER ENDS OF CANTILEVERS ARE USED TO REDUCE DEFLECTION AT OUTER END

In order to stiffen the ends of the cantilever trusses and reduce their deflections to a minimum, a double web plate girder section was used. During erection, the plate girder sections were given a camber by offsetting the rivet holes in the bottom chord in the joint connecting them to the open web section of the truss. The chords were built of 8 by 3-in. angles, latticed and placed 1 ft. 3 in., back to back, which width added to the lateral stiffness. The anchor, or wall, ends of the cantilever trusses were secured to anchor-bolts on top of reinforced columns.

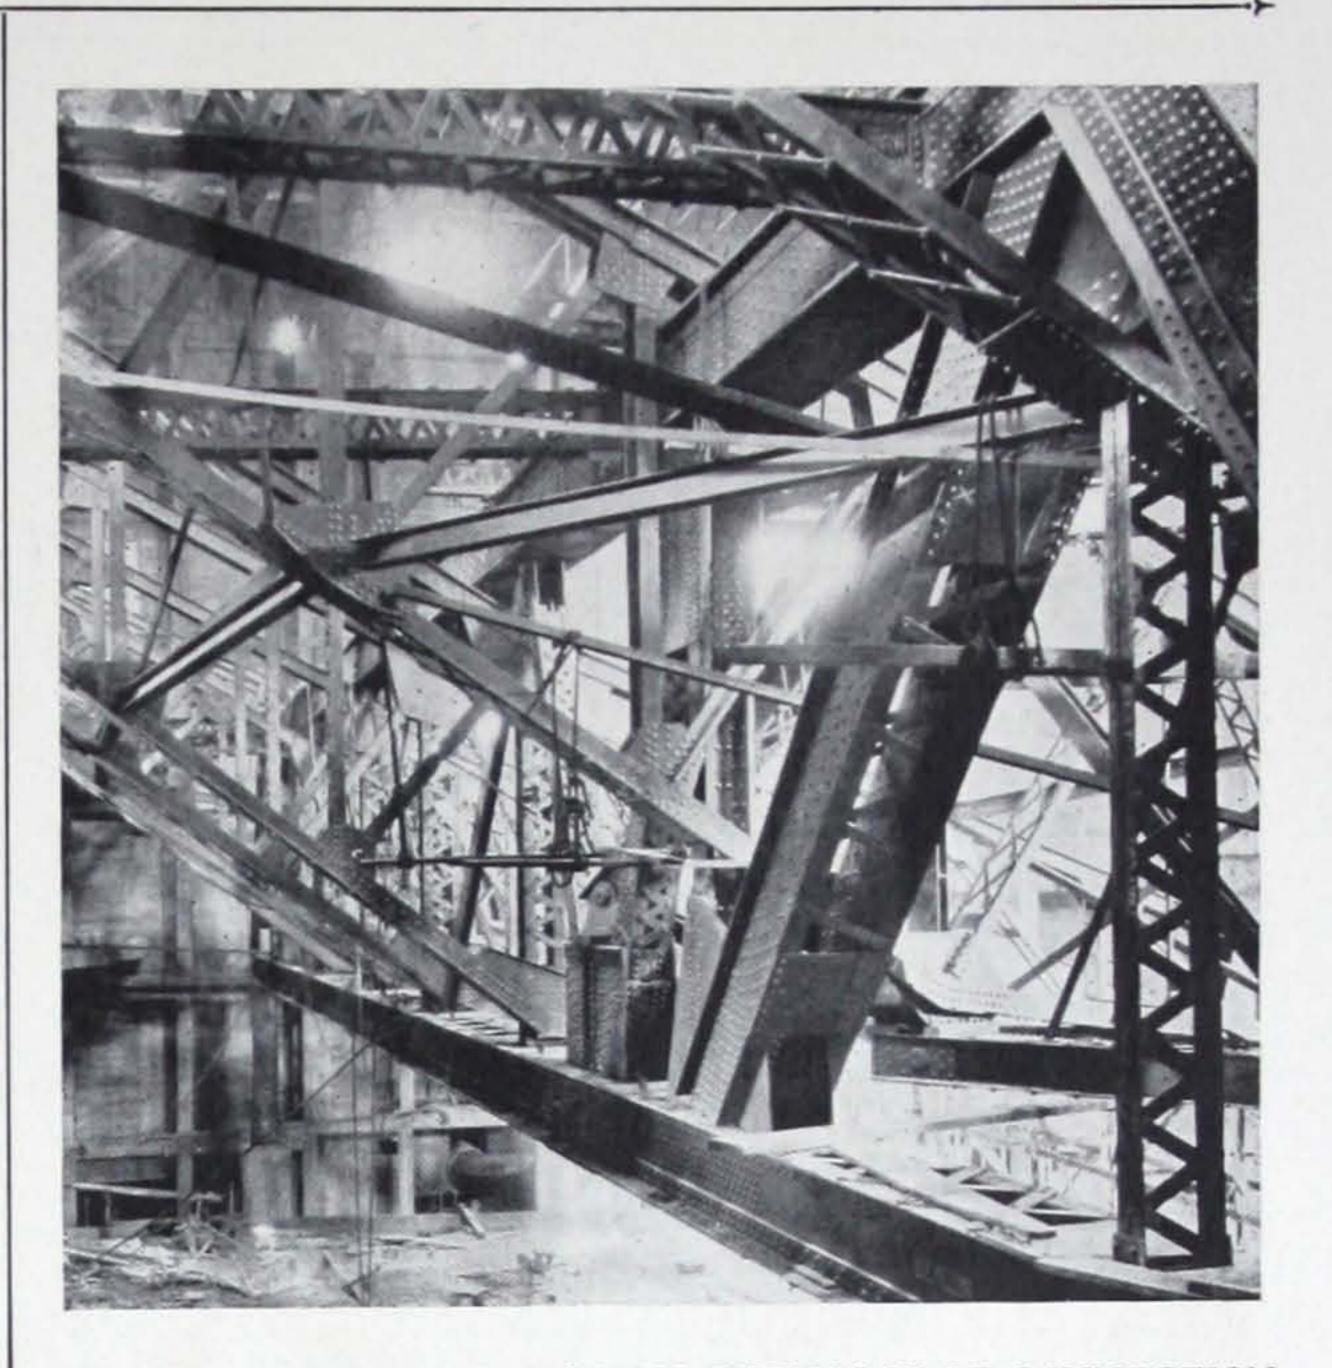
MAIN BALCONY TRUSS SHOWING INTRICACY OF CONNECTION DETAILS AND PIN CONNECTION OF JACK TRUSS TO STEEL CASTING ON MAIN TRUSS. ELECTRIC WELDING WAS USED TO OBTAIN METAL-TO-METAL CONTACT WHERE INCLINED SURFACES MADE IT DIFFICULT TO MILL ACCURATELY
