## UNUSUAL ENGINEERING FEATURES OF THE AL MALAIKAH TEMPLE,

LOS ANGELES

JOHN C. AUSTIN, Architect

By R. McC. BEANFIELD, Assoc. M. Am. Soc. C. E., Consulting Engineer

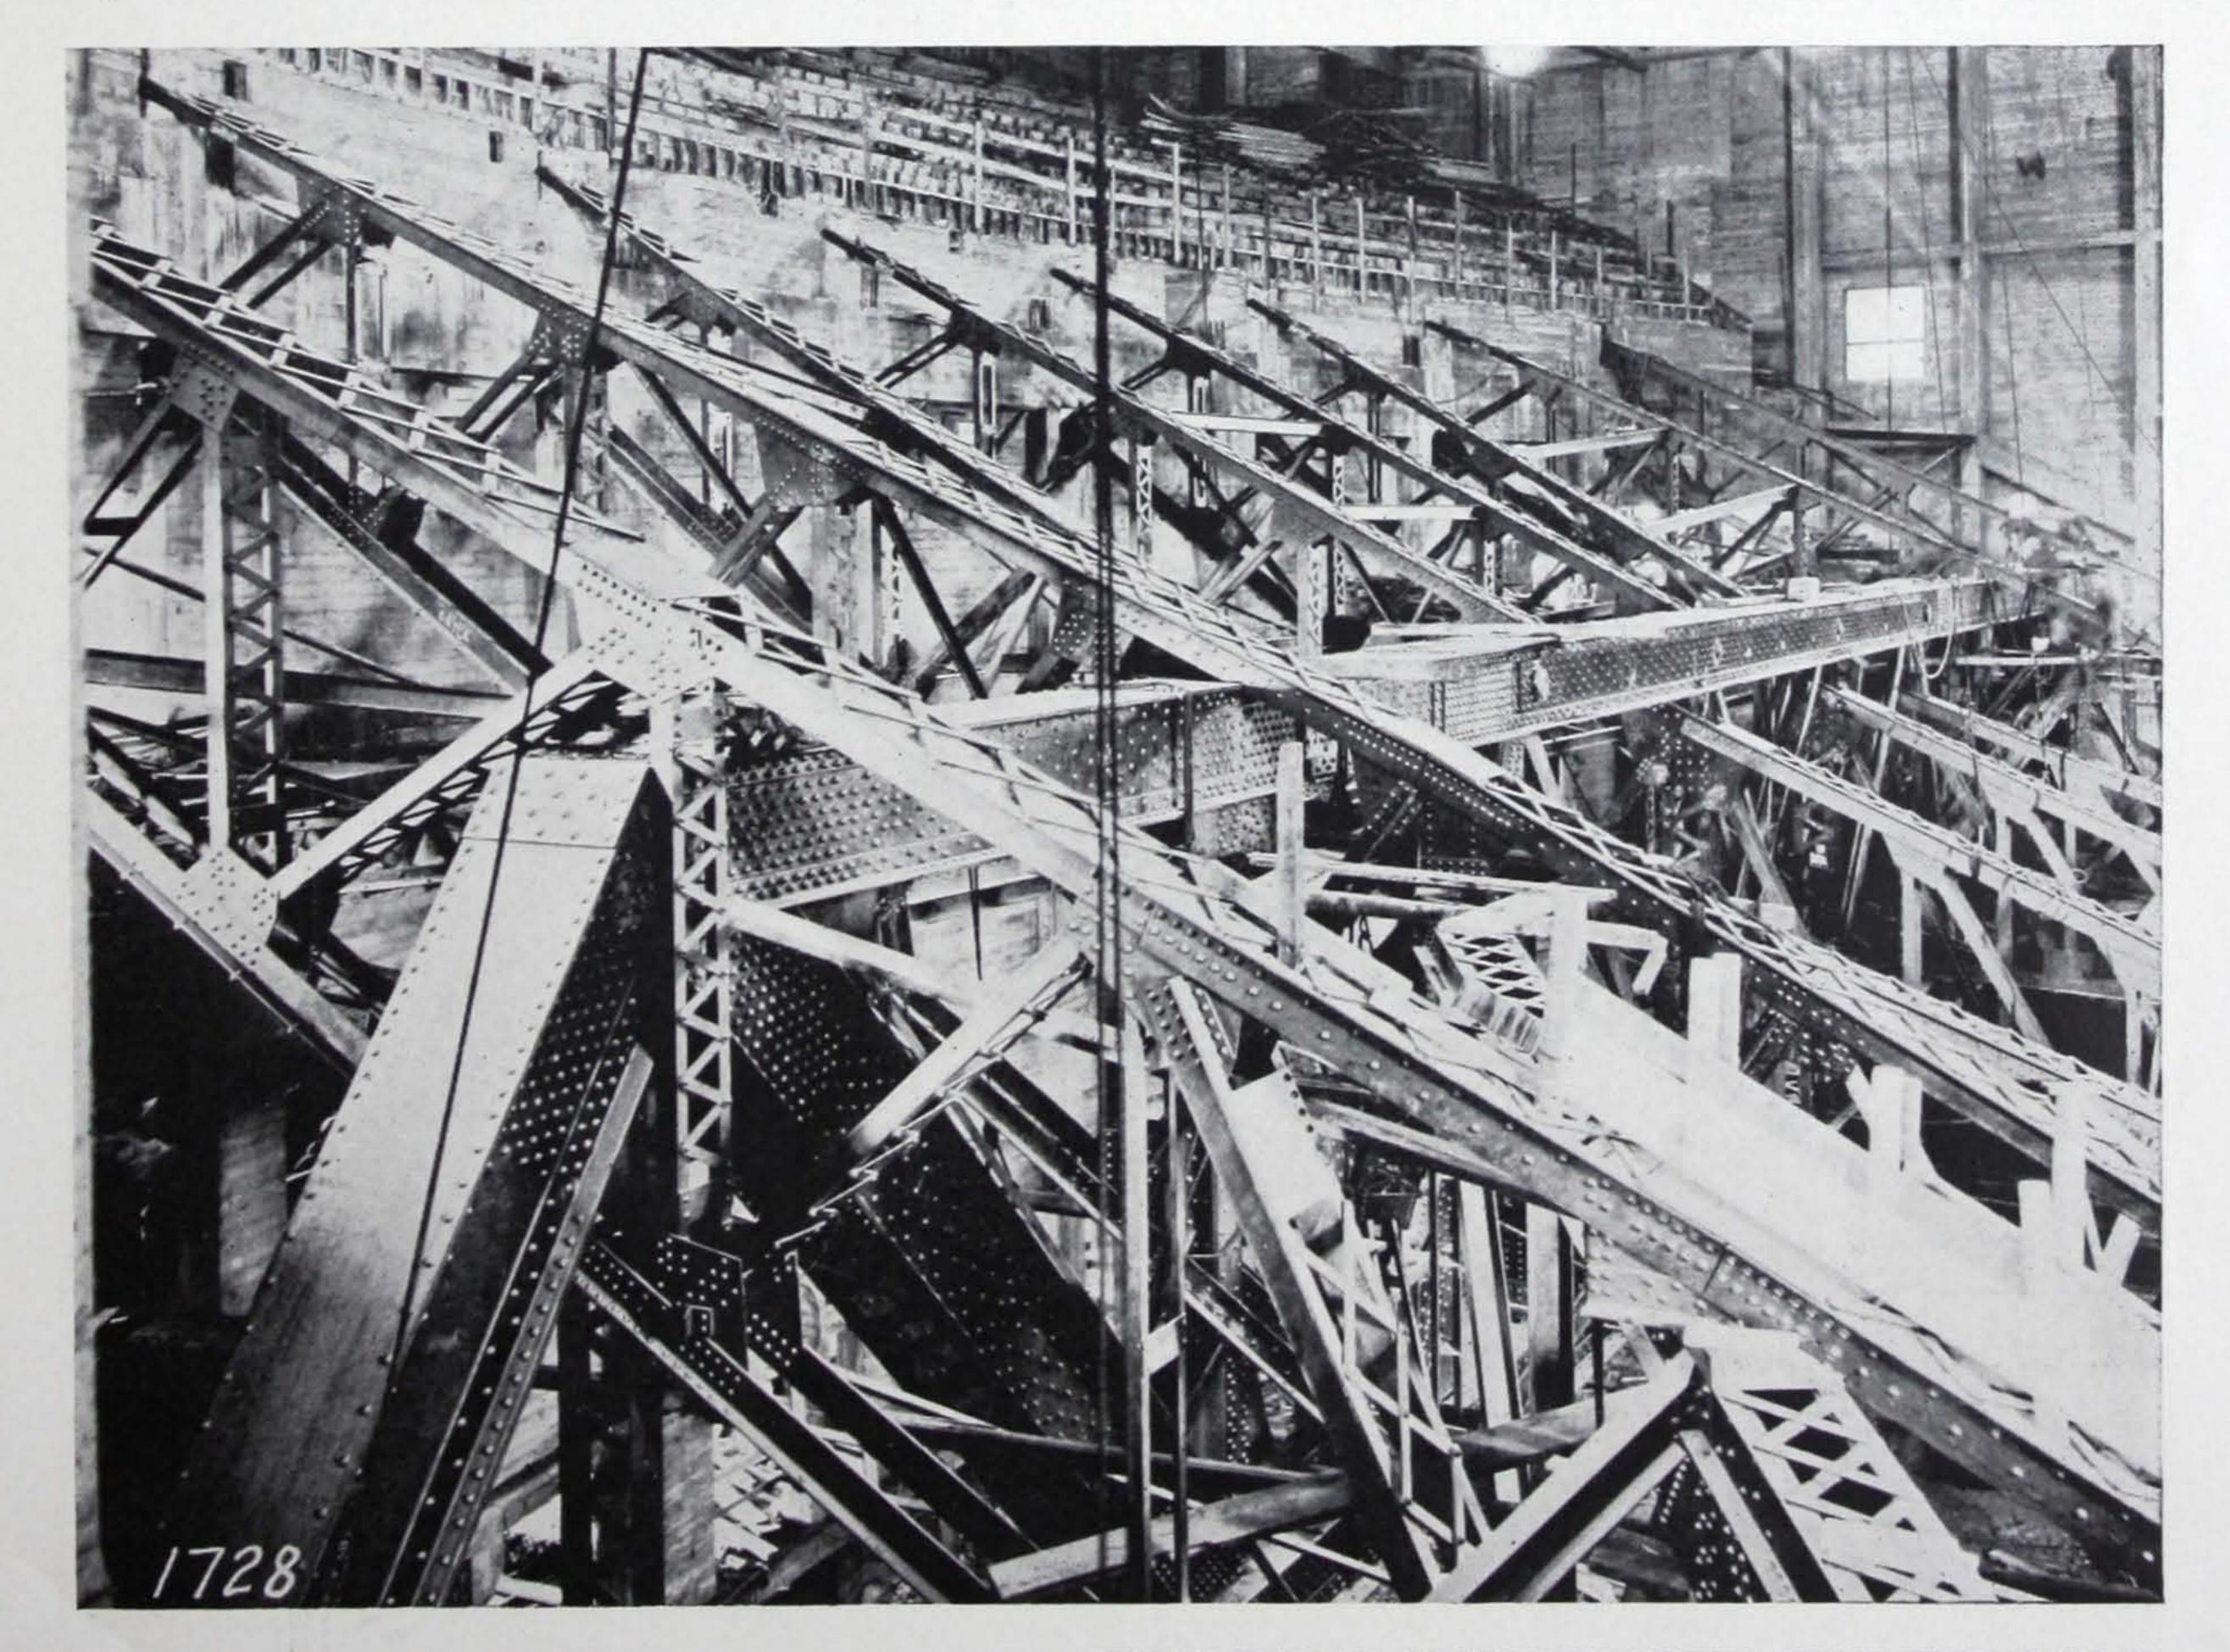
#### MAIN BALCONY TRUSS AND CANTILEVERS. CANTILEVERS WERE HOISTED TO CAMBERED POSITION. HOLES WERE DRILLED AND MATCHED BEFORE RIVETING. NOTE PIN JOINTS IN UPPER CHORD

The balcony truss was delivered to the job in sections, the largest (center lower chord section) weighing 47 tons and being 80 ft. long. The truss was erected on a steel substructure consisting of the same members as were used in the falsework for the roof trusses. The lower chord sections were first set on camber screw-jacks. The web members were next placed, and followed by the top chord sections. The jack trusses, T-1, tend to equalize the overhang of the cantilever trusses, which project a maximum of 45 ft. beyond the main balcony truss. It was desirable to prevent excessive and unequal de-

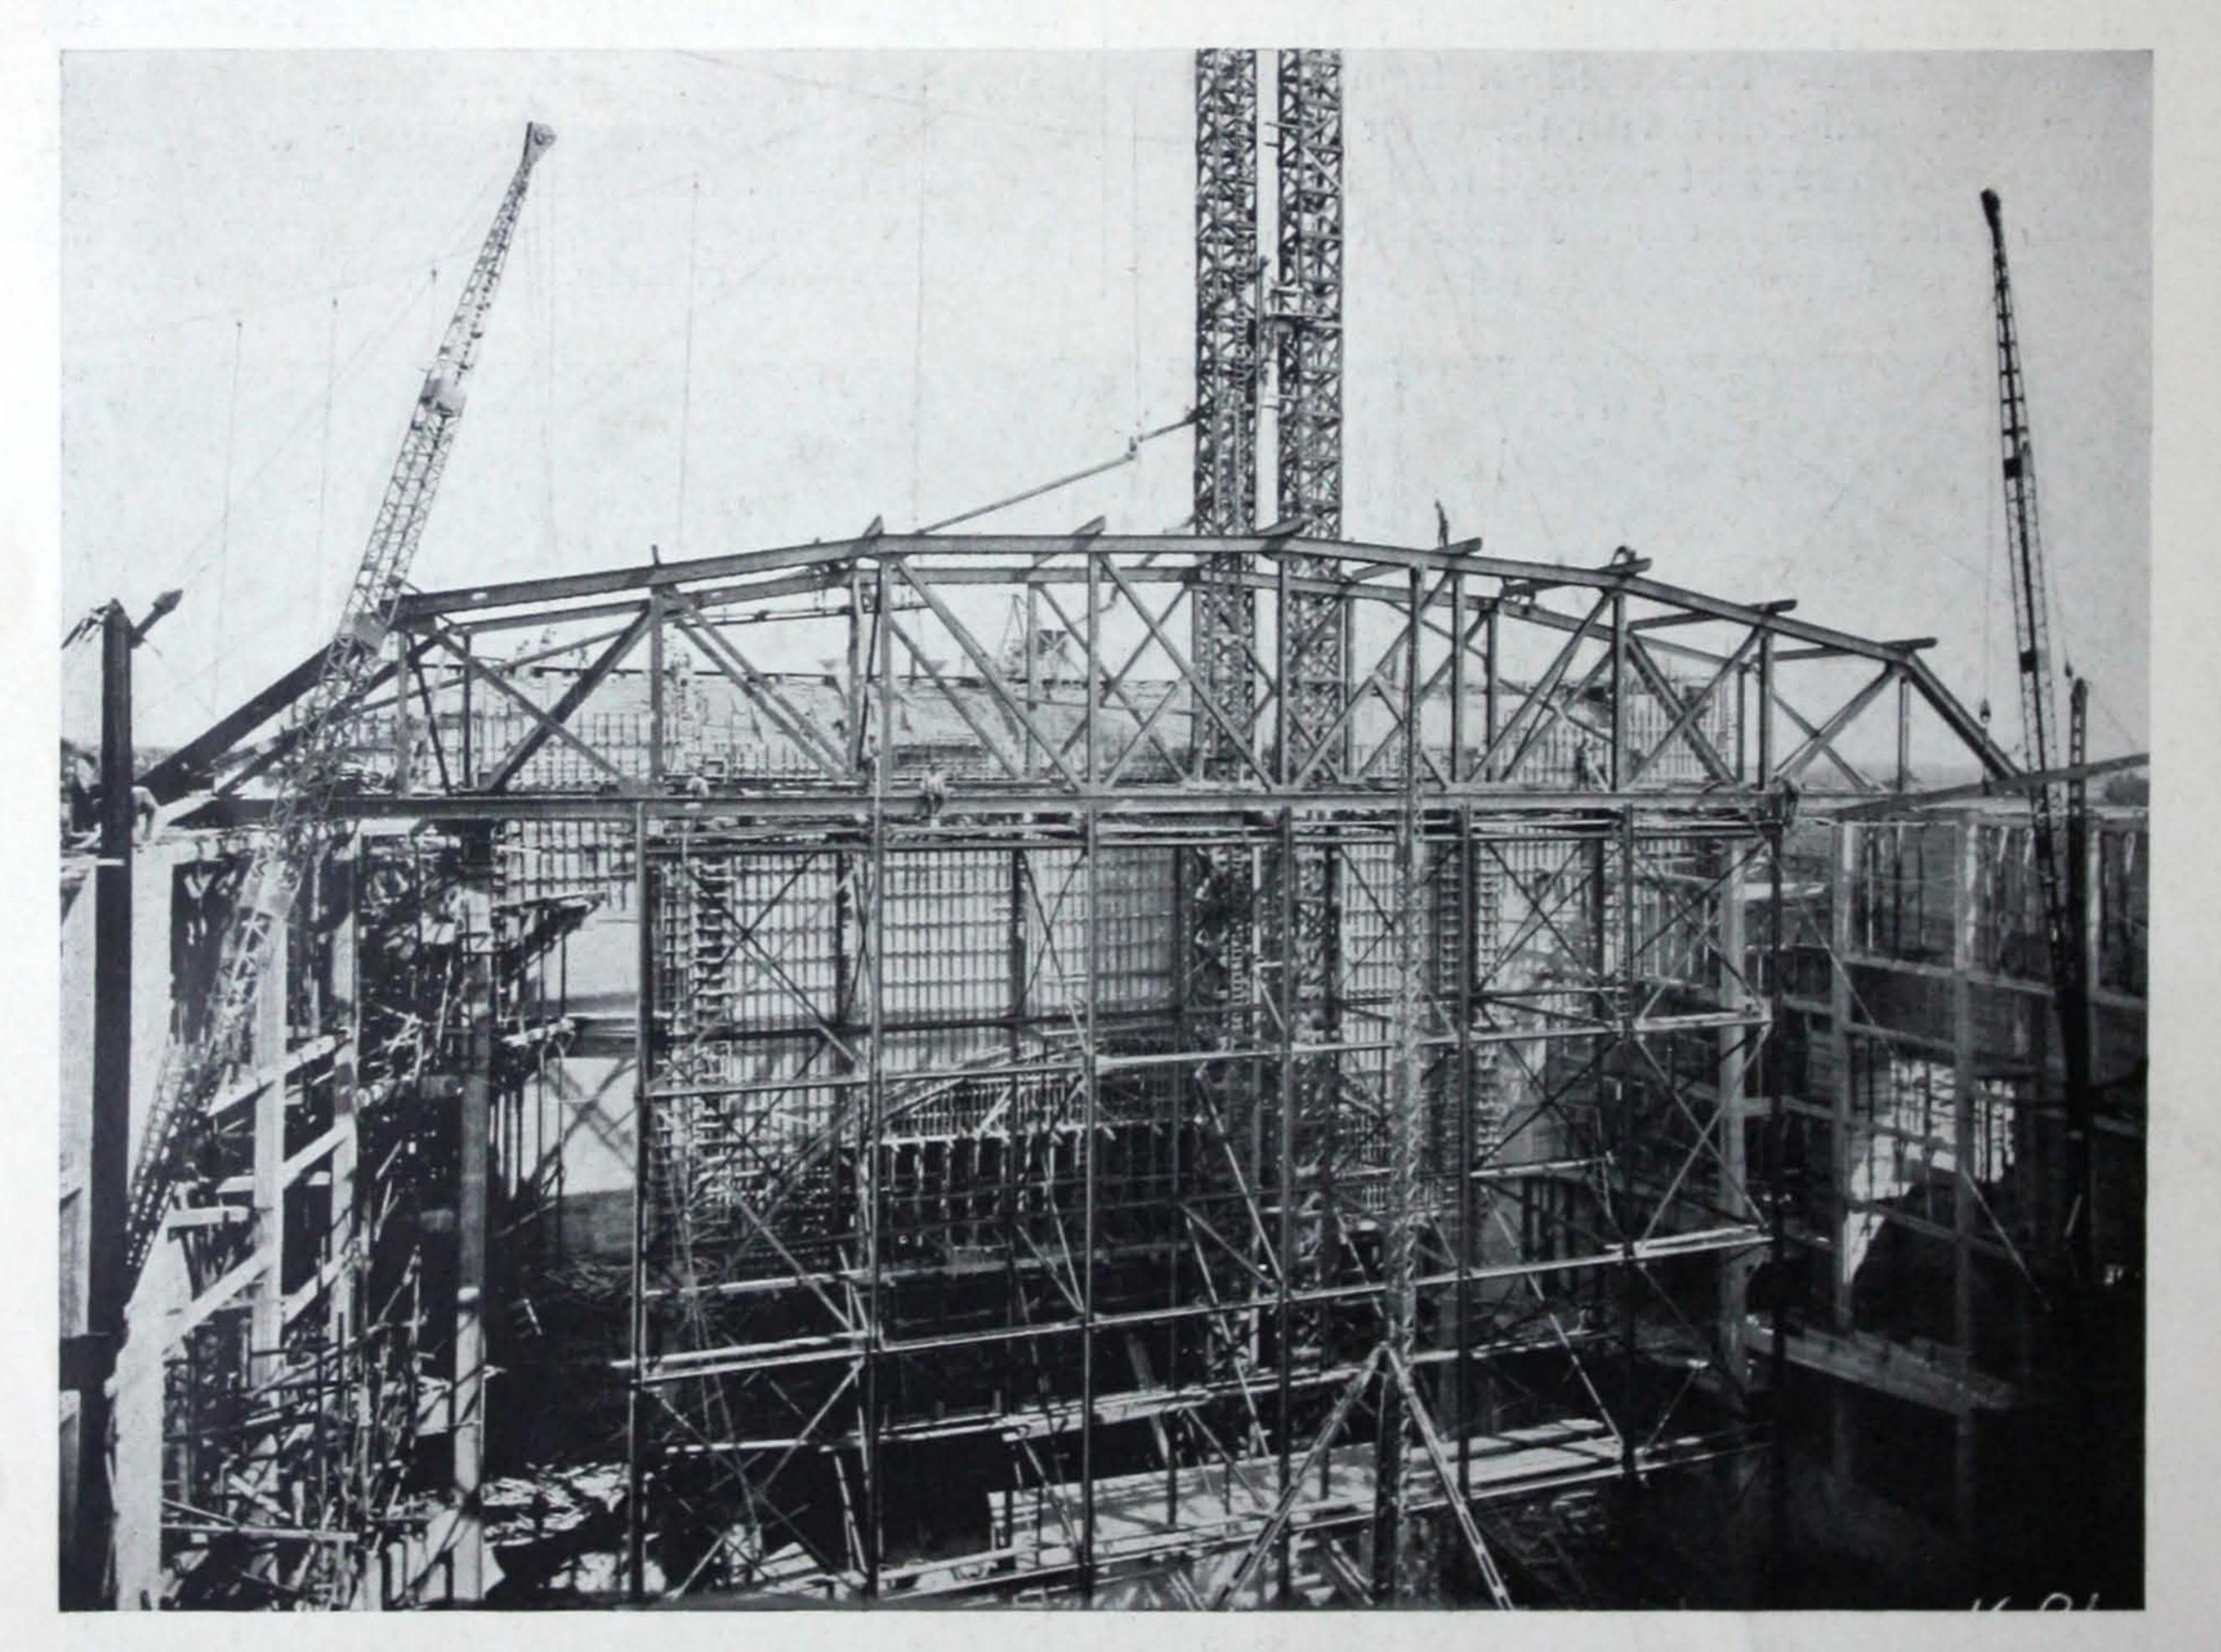
AUDITORIUM ROOF TRUSSES WEIGH 60 TONS EACH AND SPAN 192 FT. ONE END IS ON ROLLERS. ANCHOR END HAS A LEAD PLATE BEARING TO PREVENT ECCENTRIC LOADING ON REINFORCED CONCRETE COLUMNS

the roof area into sections by expansion joints to prevent excessive deformations due to heat changes. The south ends of the roof trusses were anchored; the north ends were set on nests of rollers. This provided an excellent structural connection for earthquake resistance. The roller bearings allow the roof and supporting trusses to move (horizontal translation) independently of the north supports with temperature variation, which is also a favorable structural condition of flexibility for relieving seismic stresses. If the roof trusses had been anchored at both ends, they would act like battering rams, tending to pull or push over the supports, particularly if the periods of vibration were different for the opposing supports.

To prevent excessive edge pressure on the reinforced concrete columns at the anchor end of the trusses, due to the slope at the end panel joint, a  $\frac{1}{8}$ -in. lead plate was inserted between the bearing and shoe-plates. Lateral and vertical deformations, based on Williot diagrams, checked very closely with the actual horizontal movement over the rollers (maximum,  $\frac{3}{8}$ -in.) and the vertical deflections (maximum,  $2^{3}/_{16}$ -in.).
